Attachment C

Attachment C – Aerial Photo 1971 and 2 June 2009 Photos

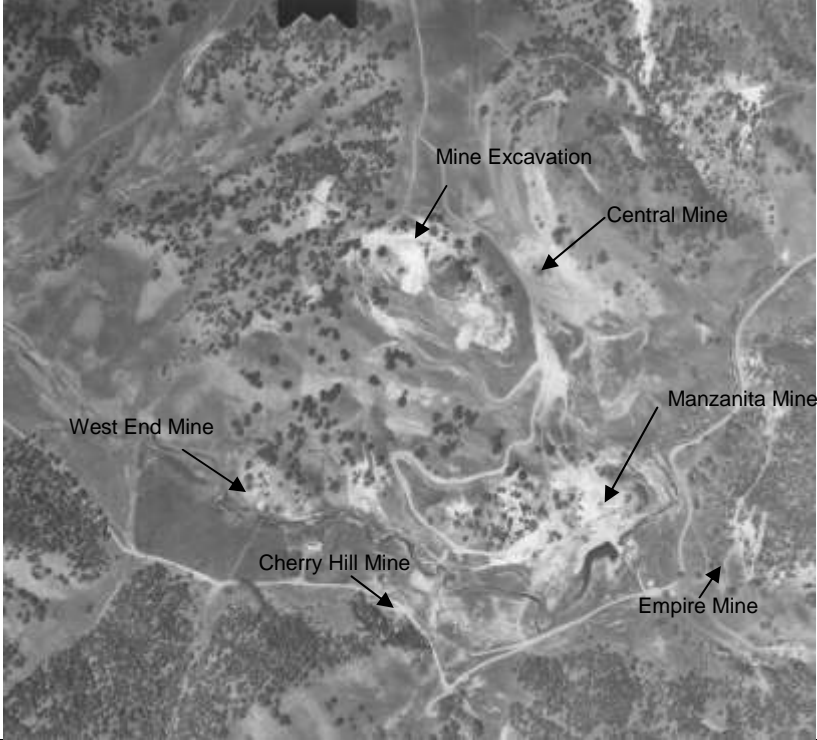
<p>This is an aerial photograph from 1971 showing a landscape with several mine sites. Labels with arrows point to the following features: 'Mine Excavation' (top center), 'Central Mine' (top right), 'Manzanita Mine' (middle right), 'West End Mine' (middle left), 'Cherry Hill Mine' (bottom left), and 'Empire Mine' (bottom right). A winding creek, Sulphur Creek, flows through the center of the image.</p>	<p>Photo 1</p> <p>This is aerial photo taken in April 1971 and was obtain from the County of Colusa. This photo shows earth moving or excavation at Manzanita and Central Mines, and excavation directly west of Central Mine. Also note directly south of Manzanita Mine, Sulphur Creek has at least been partially dammed. Several roads cross Sulphur Creek.</p>

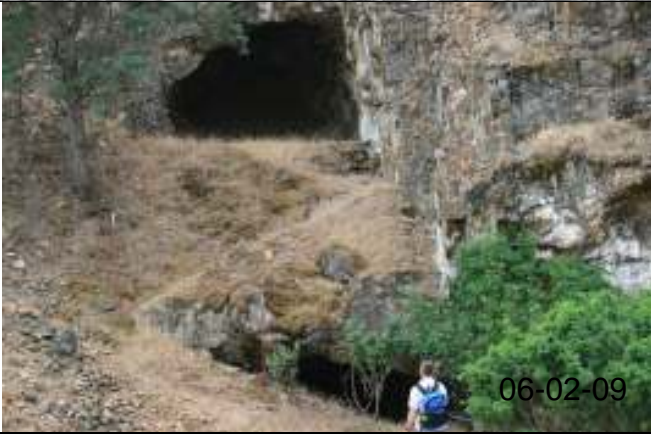
<p>A ground-level photograph showing two dark, rectangular mine portals in a hillside. A person is standing in the foreground for scale. The date '06-02-09' is visible in the bottom right corner.</p>	<p>This is two of the portals associated with Cherry Hill Mine. This mine is on a hill directly adjacent to Sulphur Creek flood plain. Waste material from this mine would or have been discharged to the Sulphur Creek Flood plain. This picture was taken from that plain looking southwest. Photo was taken by Victor Izzo.</p>

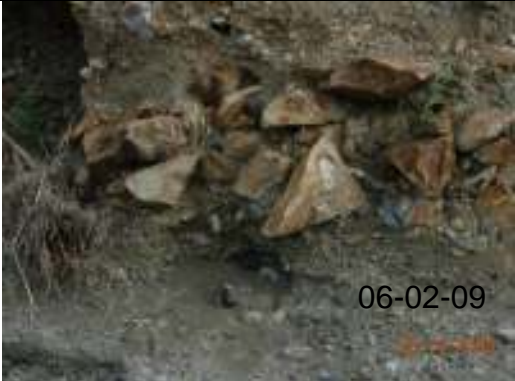
<p>A ground-level photograph showing a pile of large, angular, light-colored rocks on a dirt bank. The date '06-02-09' is visible in the bottom right corner.</p>	<p>This is a picture of angular rock in the bank of Sulphur Creek. This appears to be mining waste rock because it is not typical stream flood plain deposit. This picture was taken directly south of Manzanita Mine. Photo was taken by Jeff Huggins</p>
